## 2 Stroke Head Repair - When is it needed?

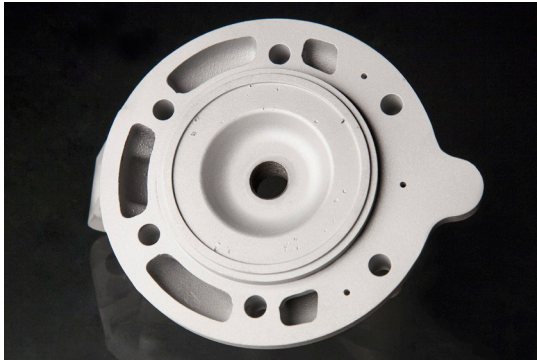
The head in the picture to the left has some very minor pitting from debris in the engine, slight detonation, or possibly a porous casting from the manufacturer. This type of pitting has no effect on performance. A light sanding and polishing of the squish angle area and the dome is all that is required. The gasket surface should always be checked on a lapping plate for flatness. Millennium offers a basic service to hand sand the combustion chamber and lightly lap the gasket surface on a surface plate.

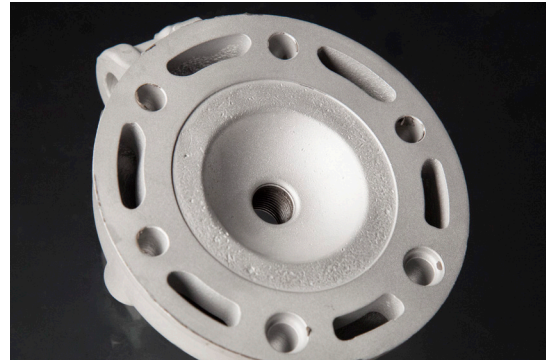
The head to the right has slightly more damage from debris in the engine. It also does not need to be repaired as performance will not be affected and there is no danger of detonation. A light sanding and polishing of the squish angle area and the dome is all that is required. The gasket surface should always be checked on a lapping plate for flatness. Millennium offers a basic service to hand sand the combustion chamber and lightly lap the gasket surface on a surface plate.

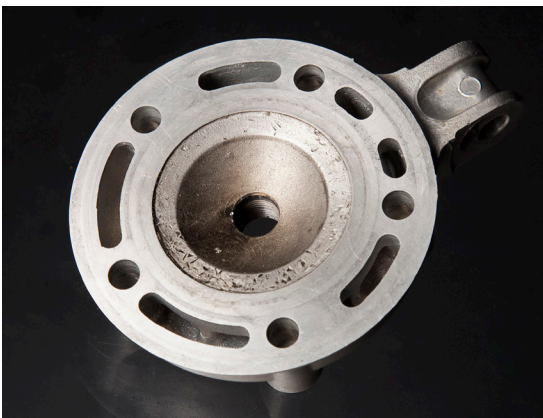
This head has moderate damage from debris caused by an engine component failure. It also does not need to be repaired as performance will not be affected and there is no danger of detonation. A light sanding and polishing of the squish angle area and the dome is all that is required. The gasket surface should always be checked on a lapping plate for flatness. If you did want to have the head repaired to eliminate the dings Millennium can weld and machine the head to OE or performance specs. It is always best to avoid welding if possible due to warpage and material hardness changes from the heat which is applied during welding.

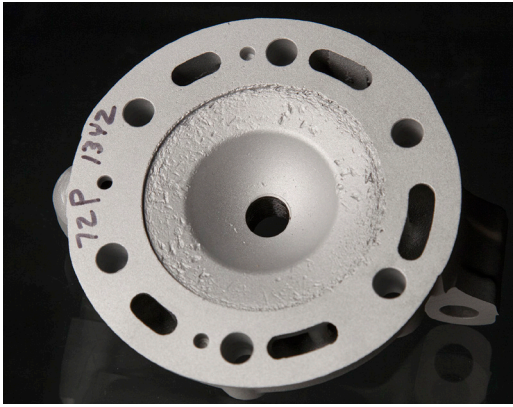
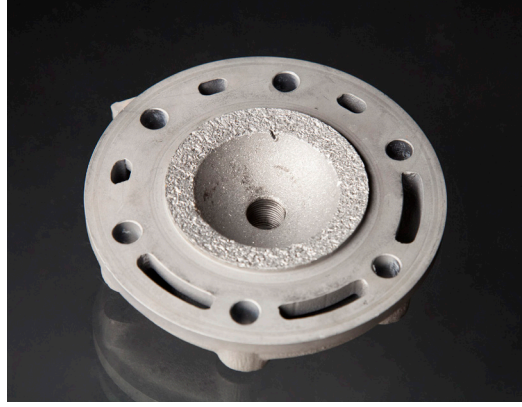
The two heads in the above pictures have extensive damage from detonation and engine component failure. Welding and machining are required to repair these heads.

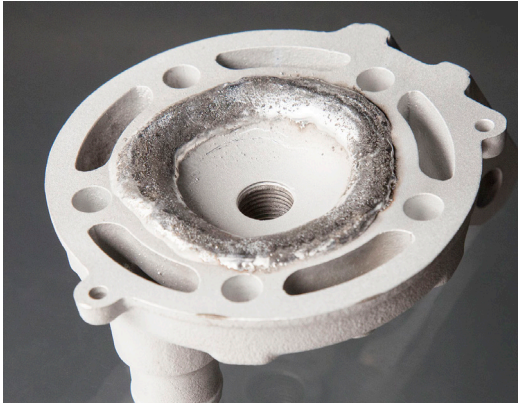
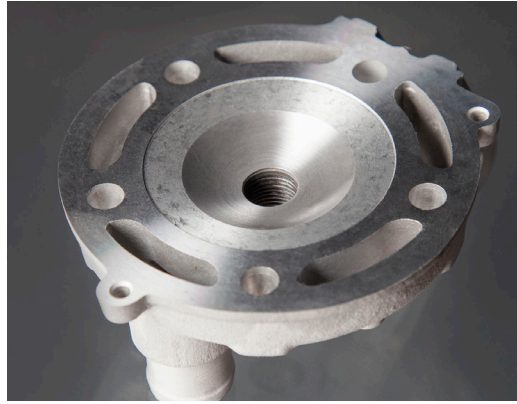
The head above had detonation damage that was repaired by welding and machining.
